Trough-Line Triumph!

Several companies have offered an upgrade service for the legendary Leak Trough-Line FM tuner in the past, but what can be achieved by amateur enthusiasts? Neville Roberts describes his approach to doing it yourself...

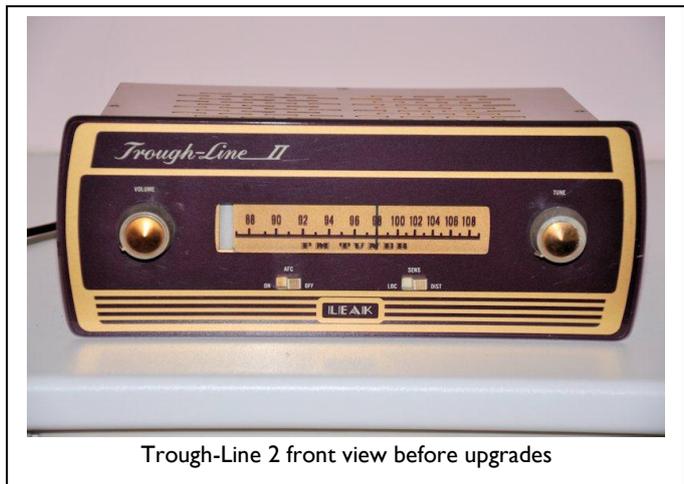
Trough-Line 2 front view before upgrades

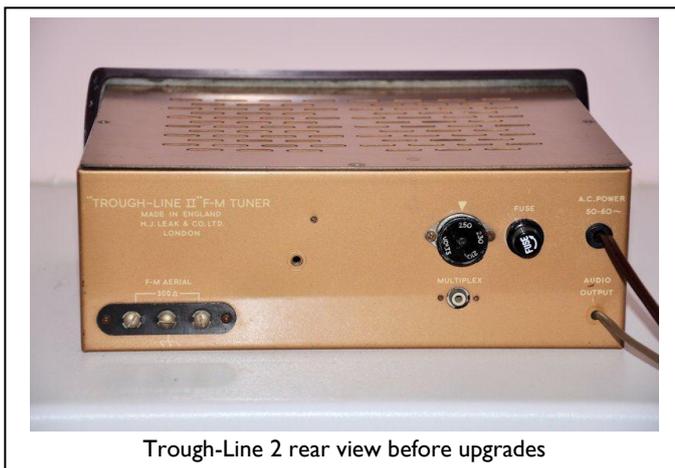
Trough-Line 2 rear view before upgrades

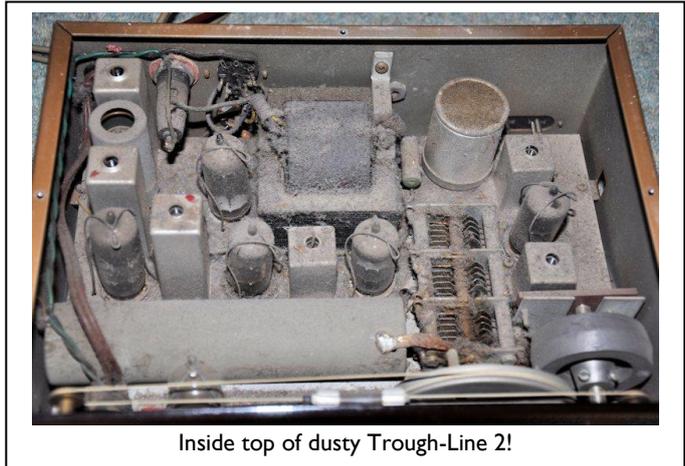
Inside top of dusty Trough-Line 2!

There are, once again, some real bargains to be had on eBay and I was fortunate enough to pick up a Trough-Line Mk.2 for £60. When my prize arrived (which was described as 'working but untested'), it was not in bad condition externally, but upon removal of the lid, it appeared to have spent most of its life stored in a vacuum cleaner dust bag (see photo)!

fuse holder, together with the mains lead, was also replaced. This was followed by a thorough vacuuming and an overall clean using isopropyl alcohol before powering it up to see how well it worked (if at all!).

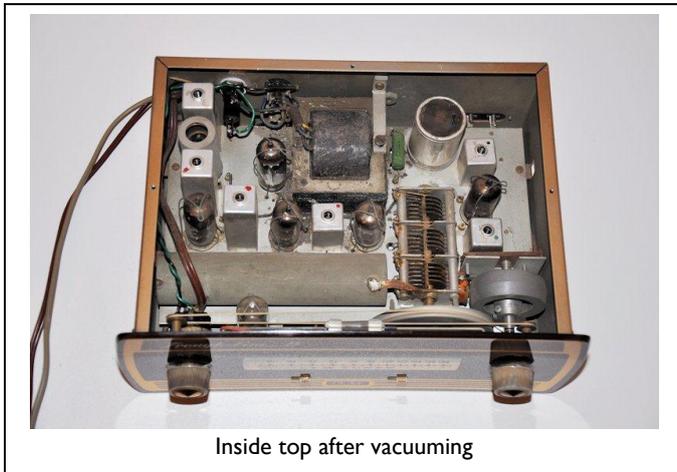
Inside top after vacuuming

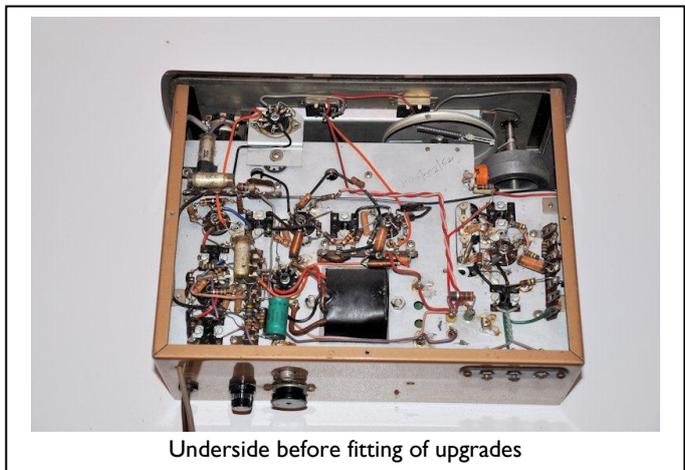
Underside before fitting of upgrades

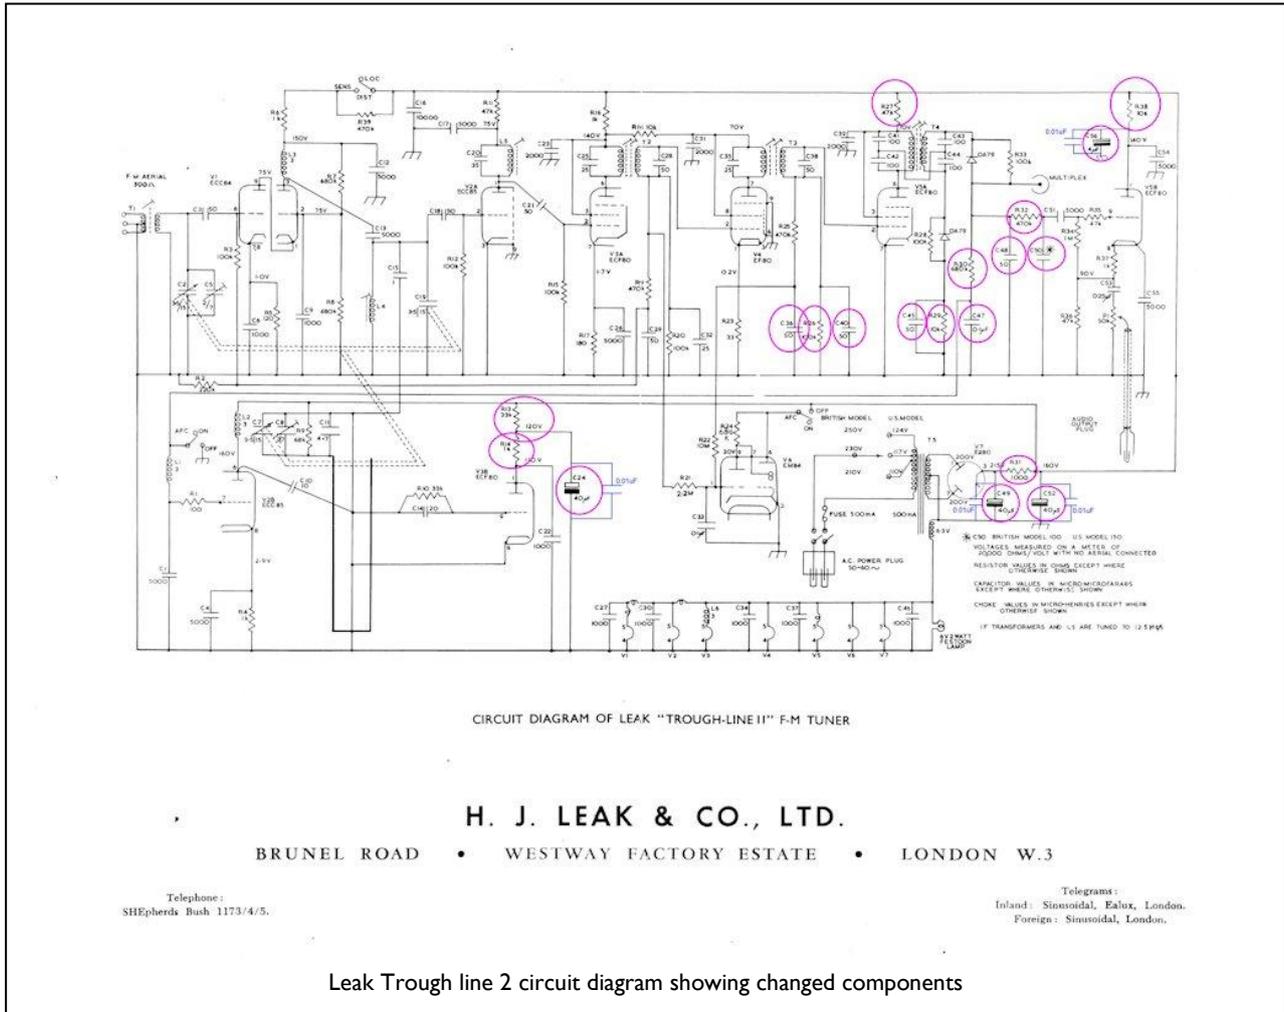
Leak Trough line 2 circuit diagram showing changed components

With reference to the circuit diagram, it can be seen that most of the components around V5B will never be used as that part of the circuit is for the mono output. Although I had replaced the volume control in my unit because of the faulty on/off switch, I removed the mono output flying lead as this will not be required after fitting the stereo decoder. In the end, I just changed the components circled on the diagram with new carbon resistors and polystyrene film for the low value capacitors. As for the 0.1uF and 0.25uF capacitors, I replaced these with 0.1uF and 0.22uF 630V Mundorf ZN capacitors respectively.

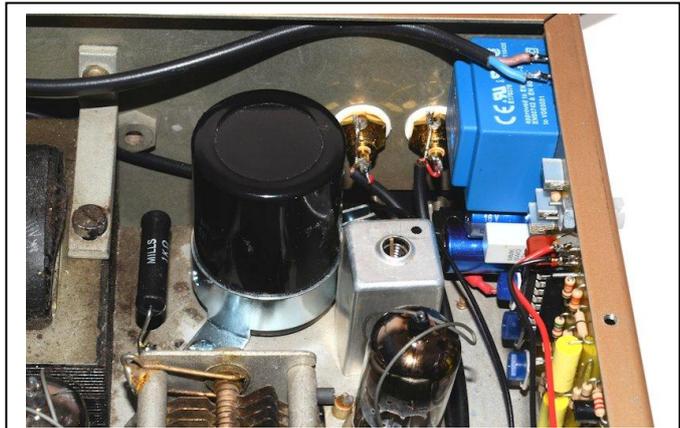
Mundorf HT capacitor and Mills series resistor fitted

So, first up was to source a replacement for the now unobtainable triple can electrolytic capacitor which would doubtless have gone leaky by now. It is essentially three 40uF 300V capacitors in one can. What I did find was a 50uF + 50uF 500V in one can – a Mundorf M-Lytic High Voltage dual power electrolytic capacitor to replace both C47 and C52 in the accompanying circuit diagram, plus a separate axial-lead Suntan 47uF 450V which fitted the bill for the third capacitor C24 nicely.

To replace the triple can, first unsolder the connections to the three solder tags. Then untwist three of the four retaining tags on the can. The fourth one is soldered to the chassis and I found the easiest way to remove it was to tap a thin screwdriver underneath it and prise it away - the capacitor then comes away easily. Using a junior hacksaw blade, I enlarged the hole by cutting away the bit of metal on the top and bottom slots. The Mundorf then fitted nicely in the space and the earth tag was soldered onto the chassis in the same place as the old can with my iron turned up to maximum heat! I also fitted a capacitor clip on the capacitor and secured it with a single nut and bolt through a hole drilled in the chassis – see photos.

The other power supply component requiring replacement was the 1K ohm 15W resistor next to the Mundorf can and that was replaced with a modern Mills wire-wound type.

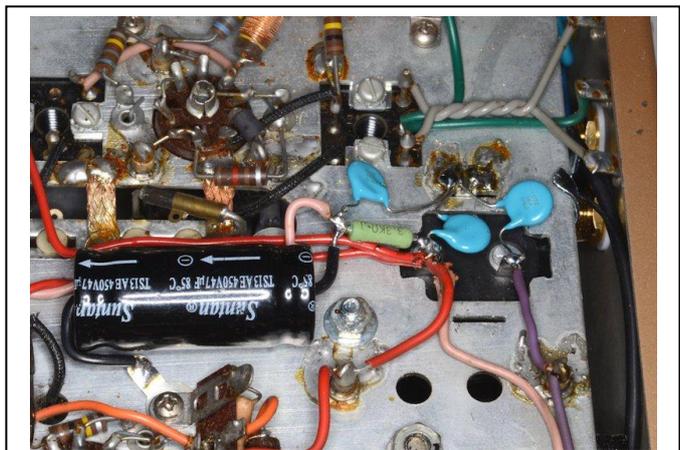
Chassis underside showing 3rd HT & bypass capacitors fitted

The next task was to replace the other electrolytic capacitor C56 (4uF 250V) with a new 4uF 600V counterpart. I also fitted all these with a bypass 0.01uF 1KV ceramic disc capacitor (the bright blue ones in the photographs) as electrolytics are not good at high frequencies.

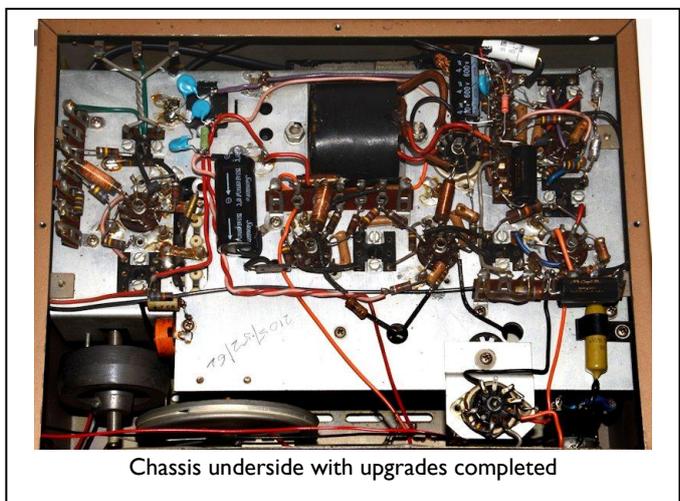
Chassis underside with upgrades completed

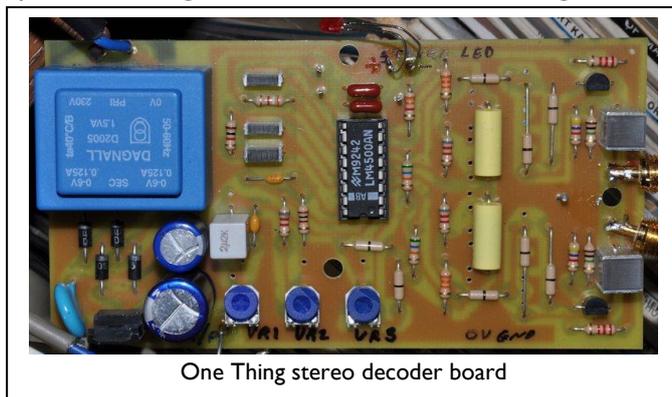
The decoder is based around the LM4500AN Hi-Fi FM demodulator. It has a quoted very low distortion figure of 0.1% and features a blend circuit which optimizes the signal-to-noise ratio under weak signal

conditions by gradually combining left and right channel information.

There are three potentiometers on the decoder board – VR1 adjusts the input gain, VR2 is the oscillator lock and VR3 is the stereo separation control. VR2 and 3 are 'factory set' and should not require adjustment, but VR1 will probably need rotating clockwise to reduce the level as the output from a Trough-Line tuner is quite high.

Following some research, I found one company, One Thing Audio, who can supply a top quality stereo decoder board, complete with its own mains power supply on board, suitable for installing in a Trough-Line for £120. They also provided me with invaluable advice on how to get the best from my unit, as well as all the extra parts to enable easy drilling of the metalwork to accommodate the decoder.

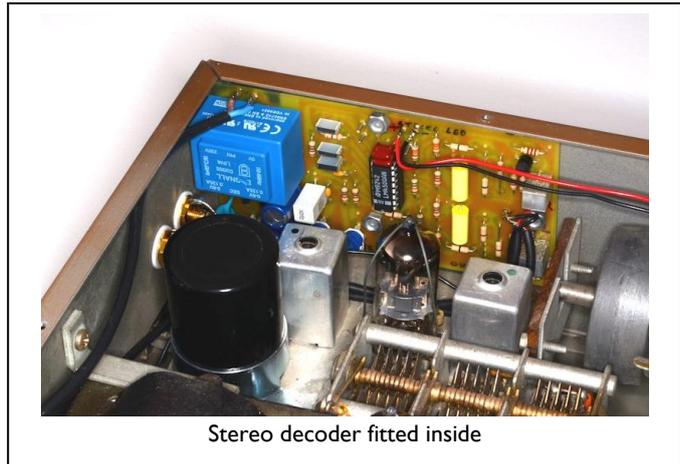
Stereo decoder fitted inside

To connect the decoder, first wire up the stereo output sockets and then connect the decoder input to the multiplex output socket (I connected this at the tag strip end, rather than the phono socket) via a supplied 1uF 160V coupling capacitor. Next, hook up the stereo LED beacon (observe the correct polarity of the LED) and finally the mains input to the connections on the Trough-Line on/off switch.

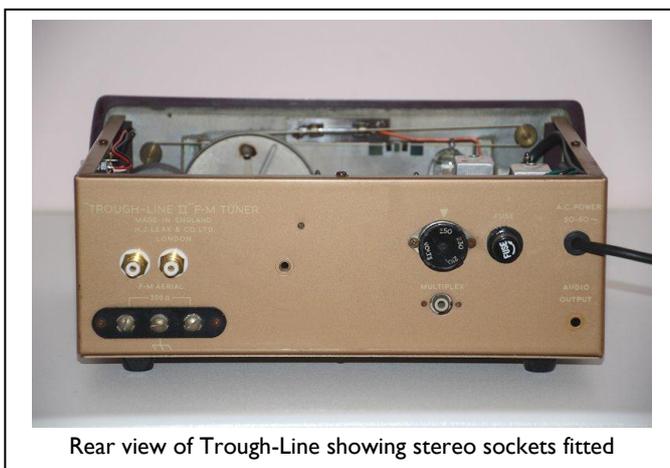
Rear view of Trough-Line showing stereo sockets fitted

The bulk of the work to fit the decoder is drilling the case to accommodate the two RCA phono sockets

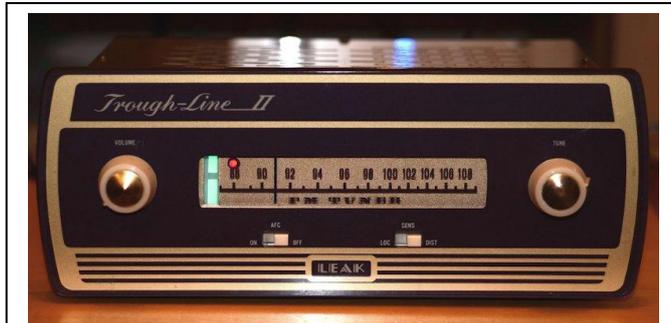
The finished Trough-Line 2 – now in stereo!
